SAS Superstructure

Daily Diary Report by Bid Item

Diary #: 468 Const Calendar Day: 843 Date: 30-Dec-2011 Friday

04-0120F4
04-SF-80-13.2/13.9
Self-Anchored
Suspension Bridge

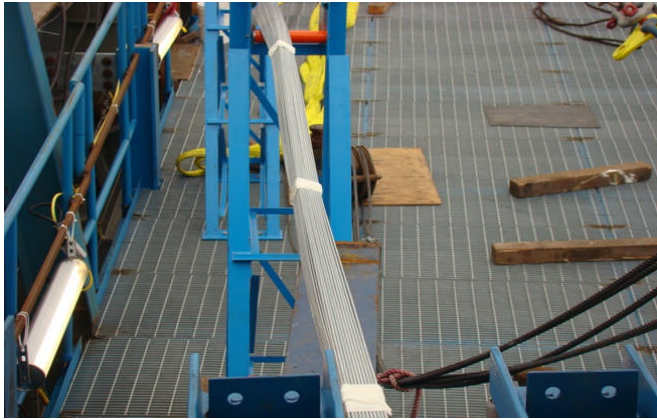
Preformed rectangular section of the west loop in the roller frames just past the east saddle around OBG lift 12W.

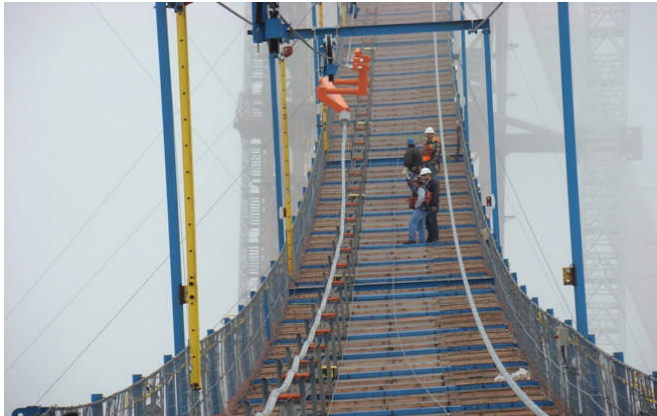
Hauling of cable strand number 2 on the north mainspan.

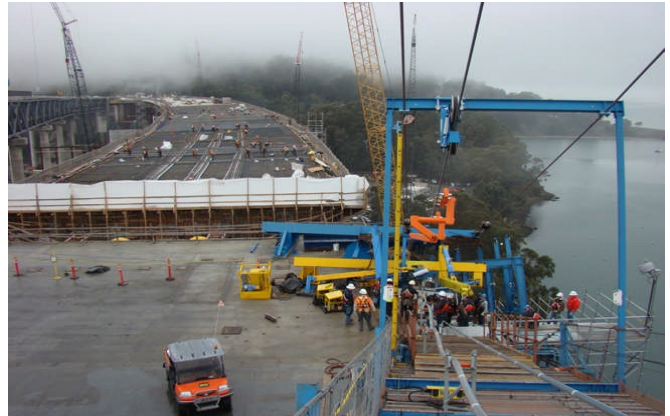
Transferring cable strand number 2 on the north side of the W2 cap beam. Also note the temporary plastic fence on the YBITS bridge.

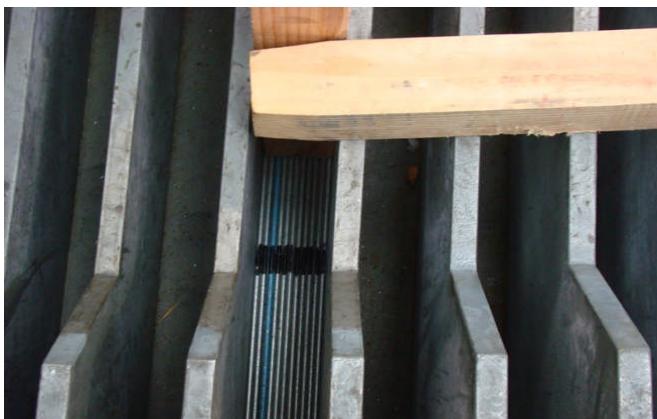
Close-up of cable strand 1 placed in the north tower saddle trough.

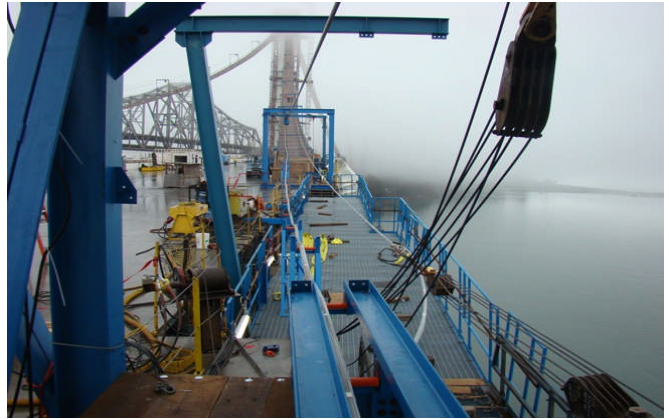
View of the north mainspan from the east saddle of cable strand 1 on the right and the hauling of cable strand 2 (in progress) on the left.

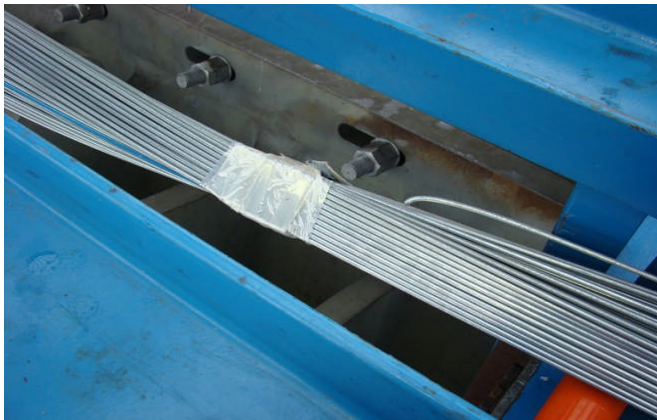
Broken wire observed near the east saddle on the north side as the cable strand was being hauled and became bound in the roller frames.

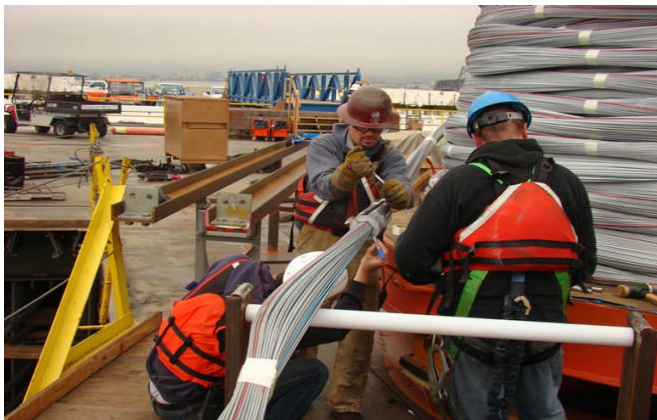
ABF ironworkers adding a hexagonal torpedo clamp a couple of meters past the end of the preformed rectangular section of the west

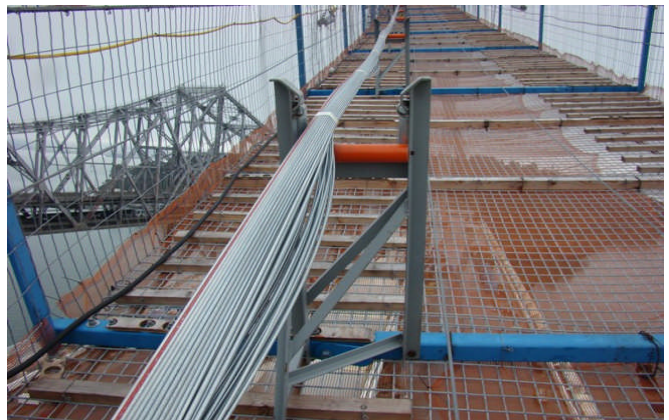
Cable strand #2 wires losing hexagonal shape in the north mainspan while the hauling socket was at the north transfer arm.

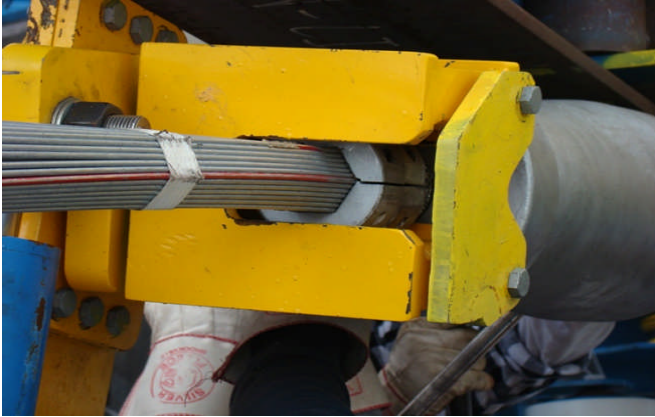
Protective clamp used for the cable strand at the north transfer arm connection while being transferred to the secondary hauling system around W2.

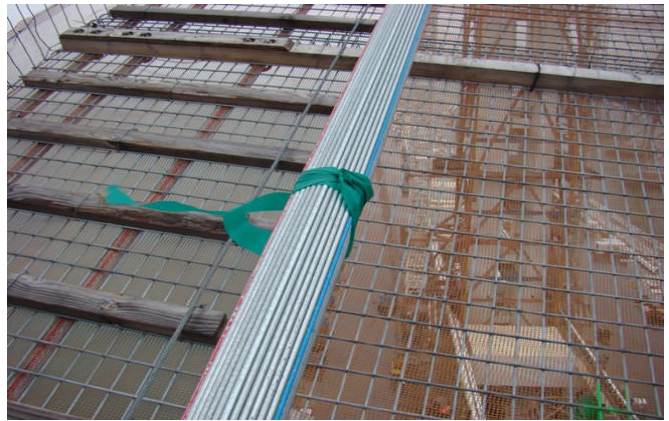
- Inspected the first cable strand placement on the north mainspan and backspan for getting initial measurements for surveying. This was done primarily to check the hexagonal shape of the wires that make-up the PWS cable strand. At the time of this inspection the cable was formed and placed in the tower saddle on the north side of the tower saddle trough. The cable socket was in the process of being connected at the east end for the north side of the cable strand. See the photos below for more details.

Acceptable hexagonal shape of cable strand number 1 for surveying with the green flagging at the midspan point of the north backspan.

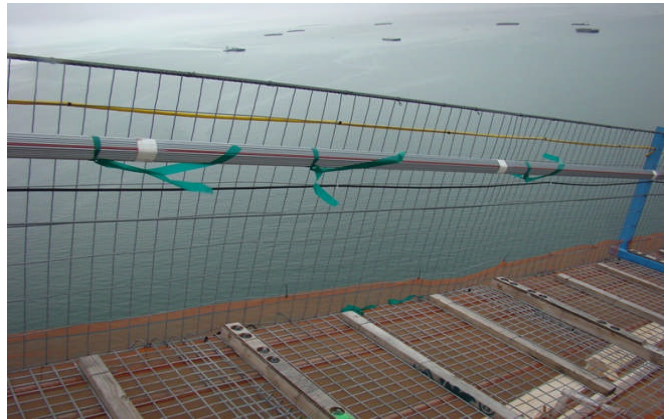
Marginally acceptable hexagonal shape of cable strand number 1 for surveying with the green flagging at the midspan point of the north main span.
